**U.S. EPA REGION VIII
TECHNICAL ENFORCEMENT PROGRAM
RCRA COMPLIANCE EVALUATION INSPECTION REPORT**

Facility: Frontier Refining, Inc.
2700 East 5th Street
Cheyenne, WY 82007

Inspection Type: Corrective Action Compliance Inspection
For Pond 2 Clean-Out

Date: October 17, 2011

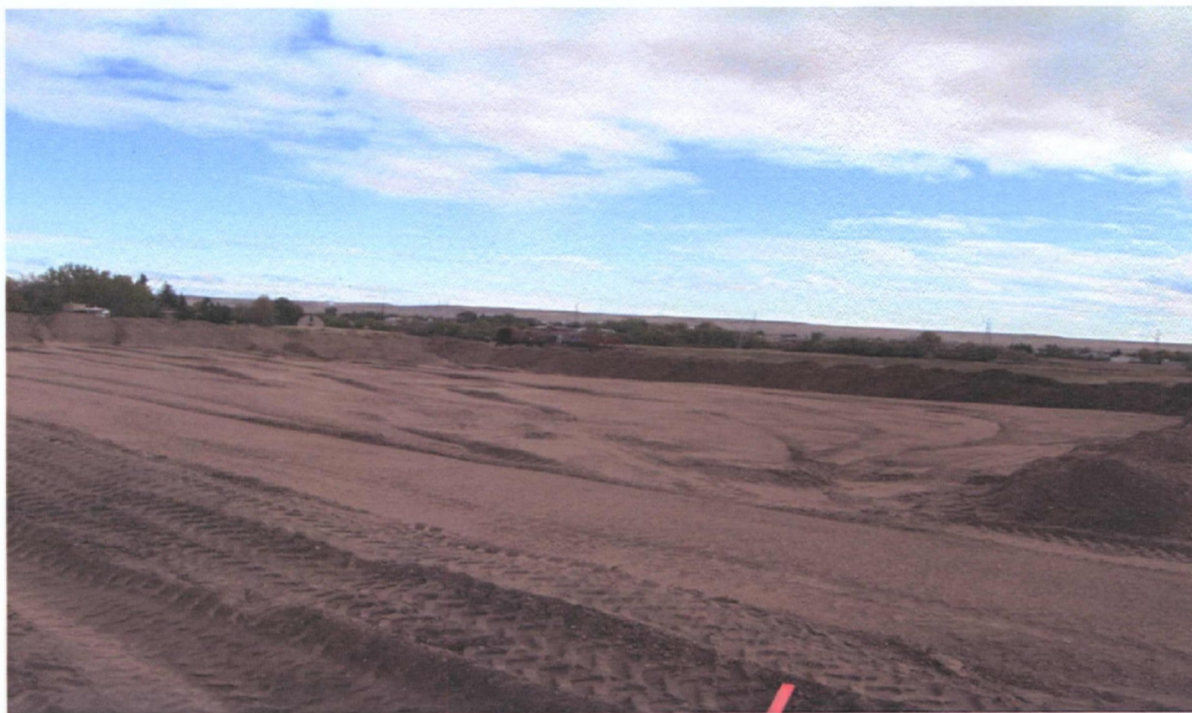
Photo: 1

**Subject: One of Three Storage Pads
Being Constructed for Pond 2 Spoils**

Mr. Weeks updated the inspectors on the progress of the Pond 2 work as they drove to the site of three pads which were being constructed for storage of clay and dirt. One pad was to be used for storage of contaminated clay, potentially a hazardous waste, the second for other clay material, and the third for dirt to be used for reconstruction of the Pond 2 footprint to serve as the tank base. These pads were to be lined with a semi-permeable liner.

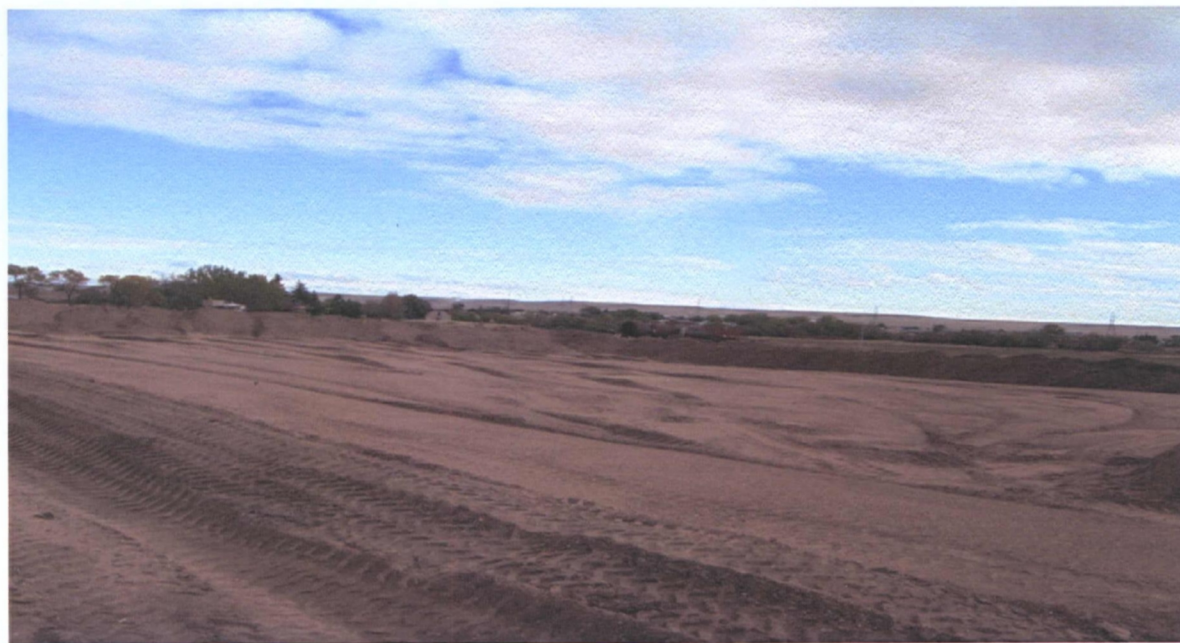
Photo: 2

**Subject: Storage Pad for Pond 2
Excavated Materials**

Ms. Jacobson completed the NOI form and held a short closing conference. No concerns were noted for the scope of the inspection conducted. Ms. Jacobson contacted Mr. Weeks with concern that a semi-permeable liner should not be used in the concrete pad used for the contaminated clay material which was potentially hazardous waste. He clarified that he had misspoken and that the liner would not allow seepage into the soils beneath the pad.

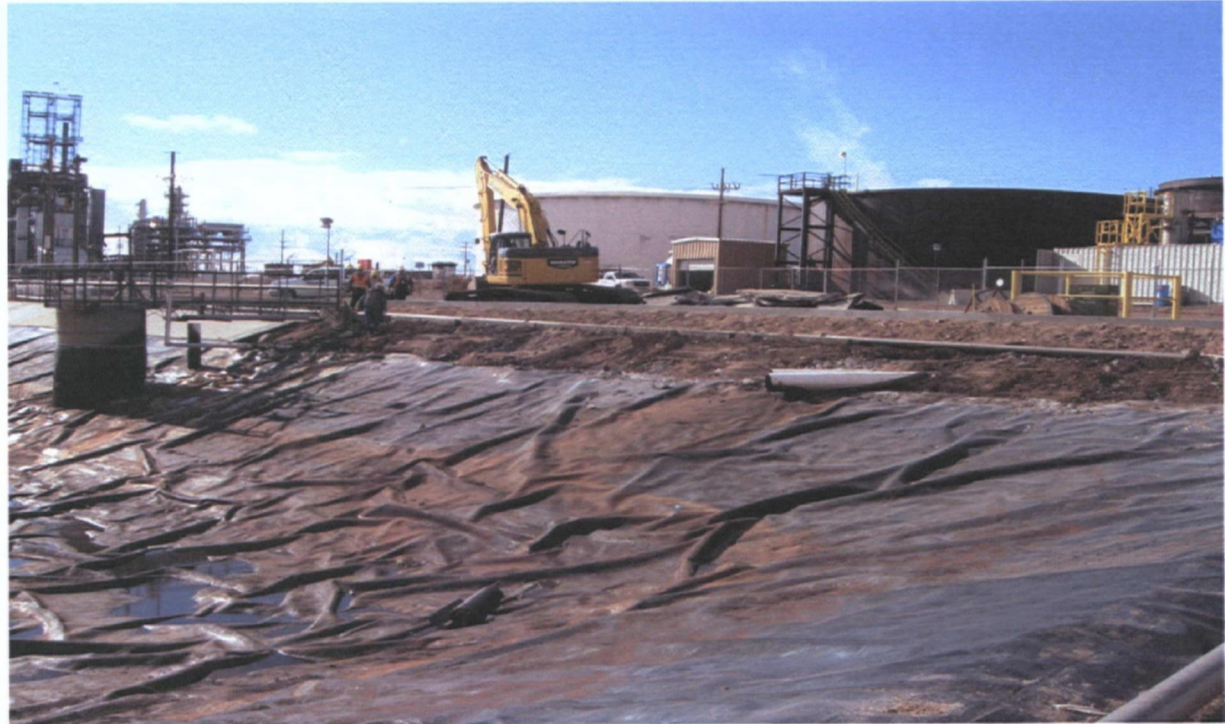
Photo: 3
Facility: Frontier Refining
Subject: Pond 2 with Portion of
Concrete Apron Removed
Photographer: Linda Jacobson
Date: October 17, 2011

The inspectors and facility representative arrived at the former Pond 2. Only the concrete apron on the north end was remaining. The facility had rinsed off the liner and removed the rinse water and other ponded water. Mr. Weeks stated that the existing synthetic liner will be cut up and put into roll-offs for proper disposal.

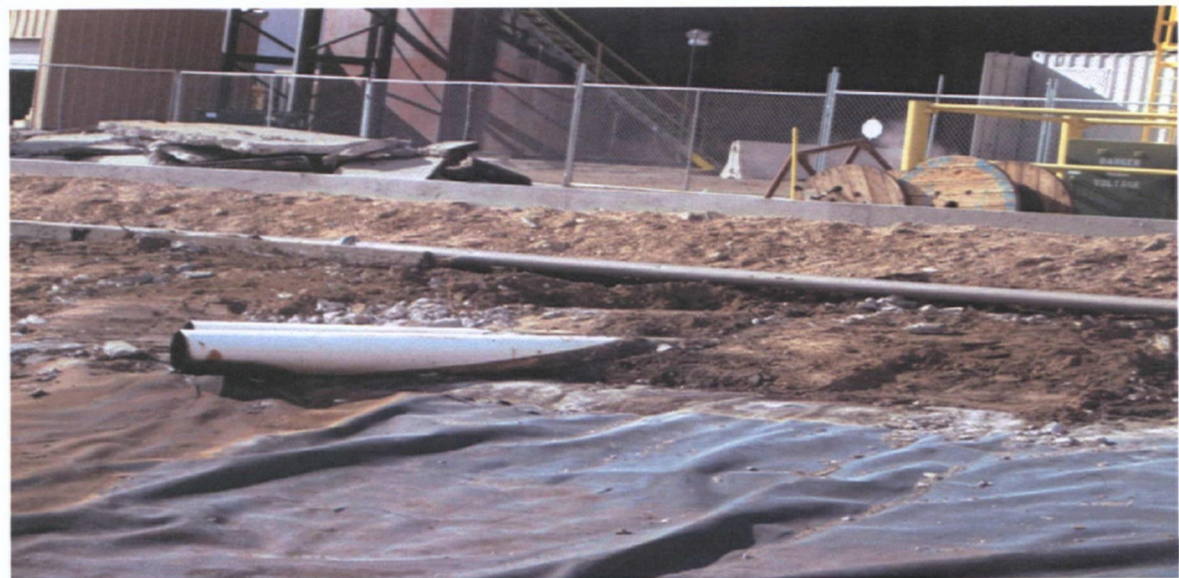
Photo: 4
Facility: Frontier Refining
Subject: Inlet Piping Plugged for
Liner Removal Work
Photographer: Linda Jacobson
Date: October 17, 2011

The inlet lines had been plugged. A continuing discharge, possibly groundwater, was still daylighting into the pond. The refinery was attempting to identify this water source and seal or remediate it.

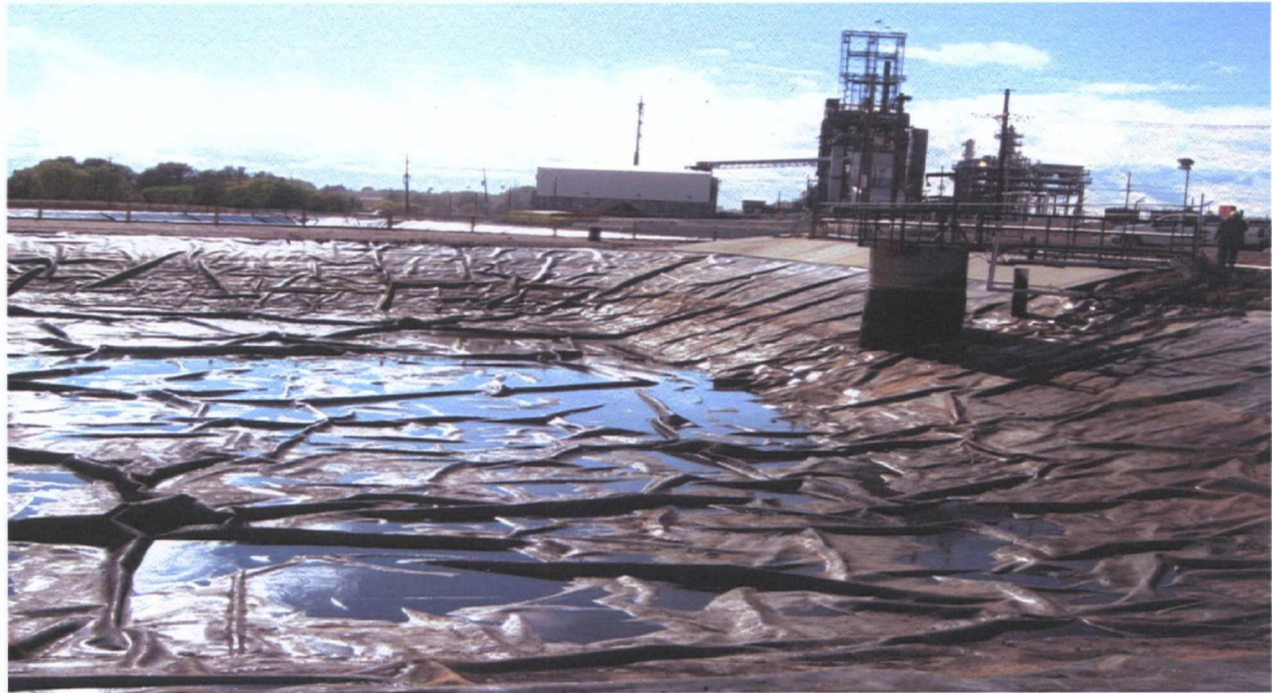
Photo: 5

Facility: Frontier Refining
Subject: Areas of Ponded Water
to Be Removed by Vacuum Truck
Photographer: Linda Jacobson
Date: October 17, 2011

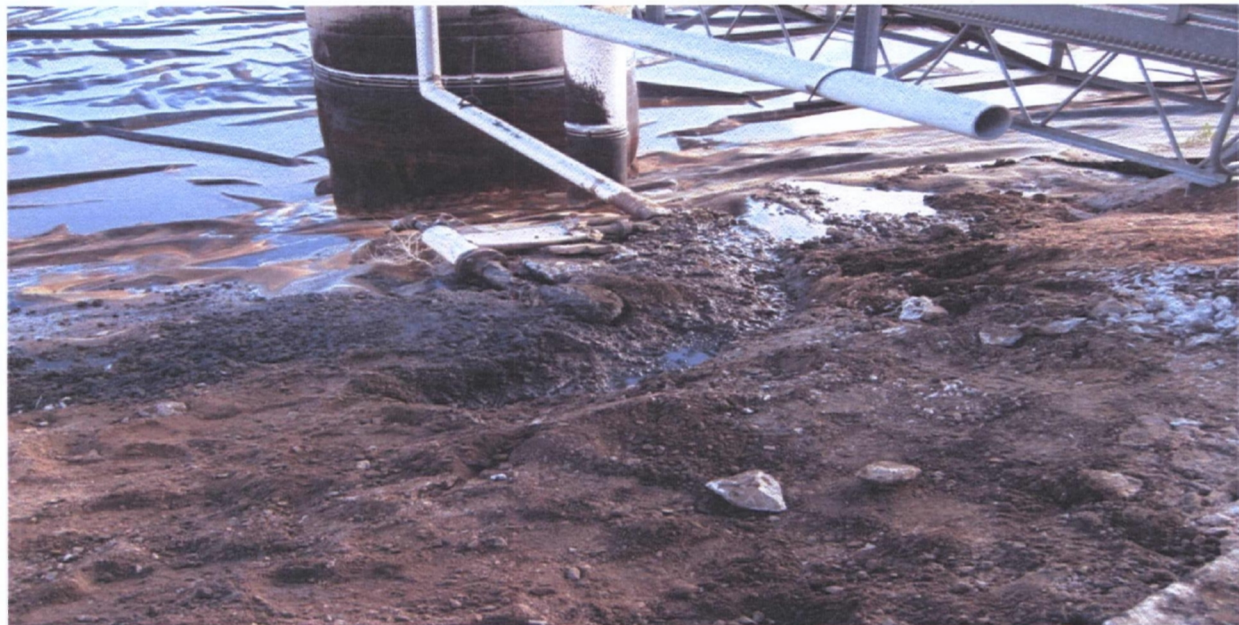
Photo: 6

Facility: Frontier Refining
Subject: Continuing Inflow of Water,
Possibly Groundwater
Photographer: Linda Jacobson
Date: October 17, 2011

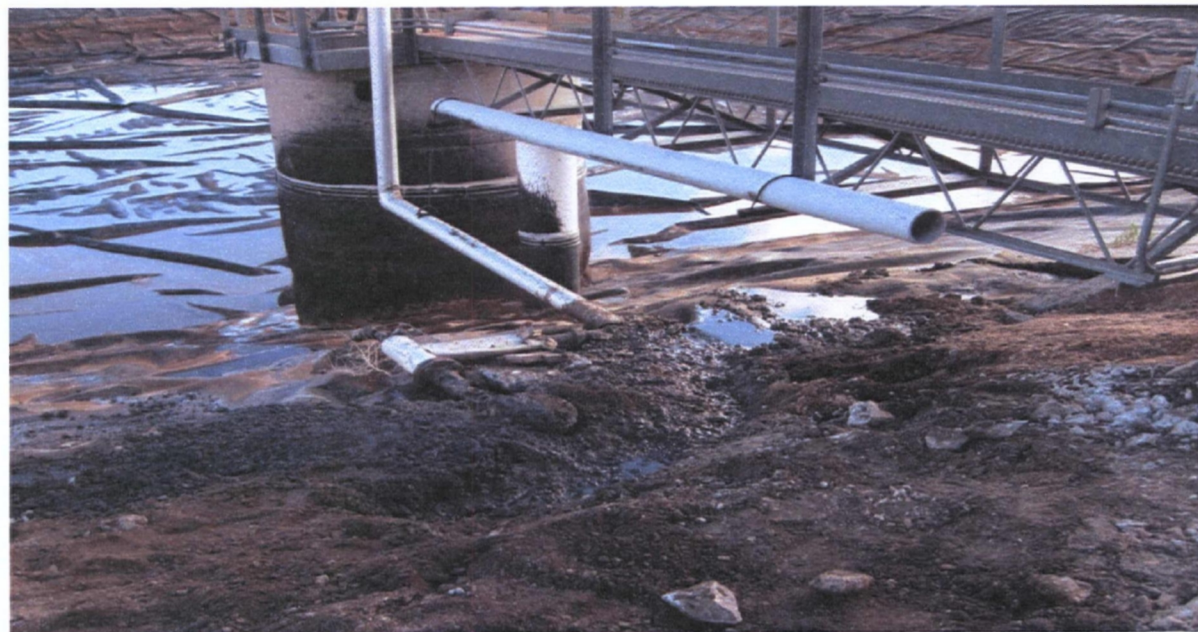
Photo: 7

Subject: Location of Water Seep

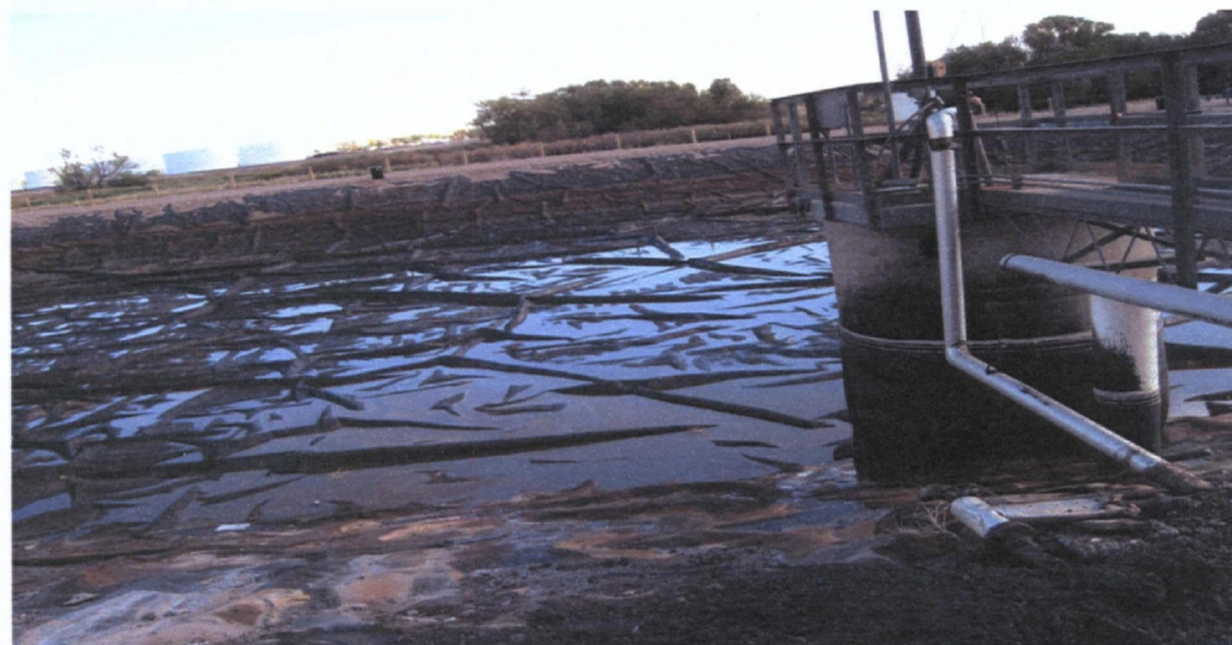
Photo: 8

**Subject: Pond 2 Prior to
Synthetic Liner Being Pulled**

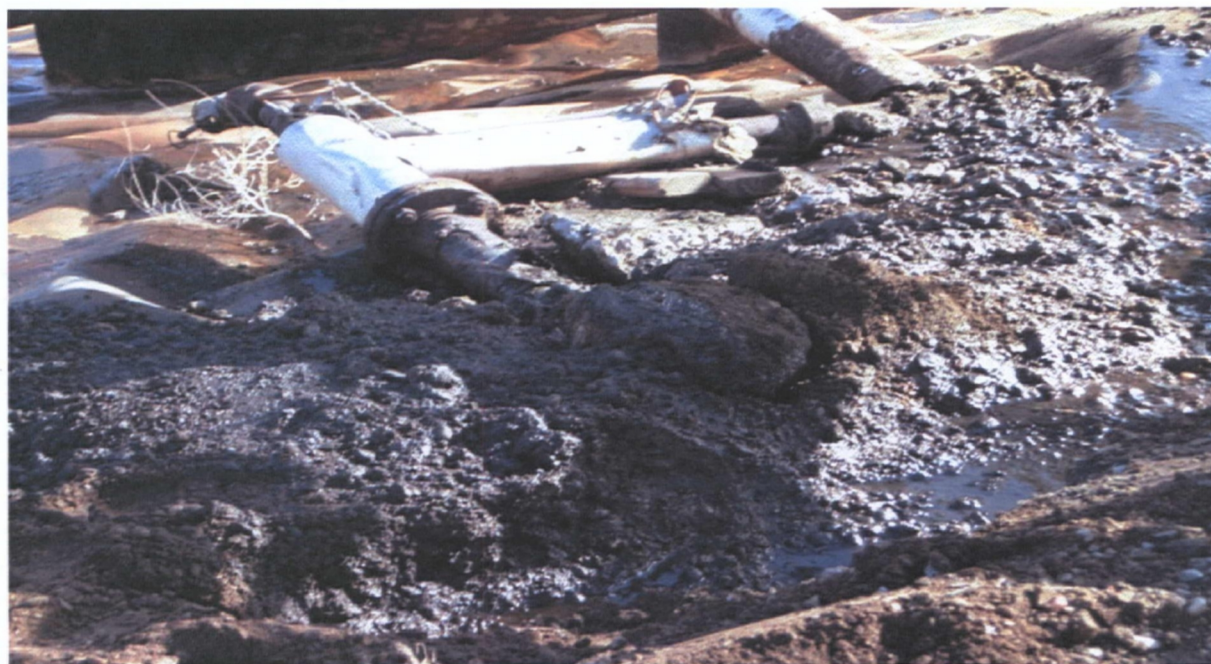
Photo: 9
Facility: Frontier Refining
Subject: Water Flow into Pond 2,
Possibly Groundwater
Photographer: Linda Jacobson
Date: October 17, 2011

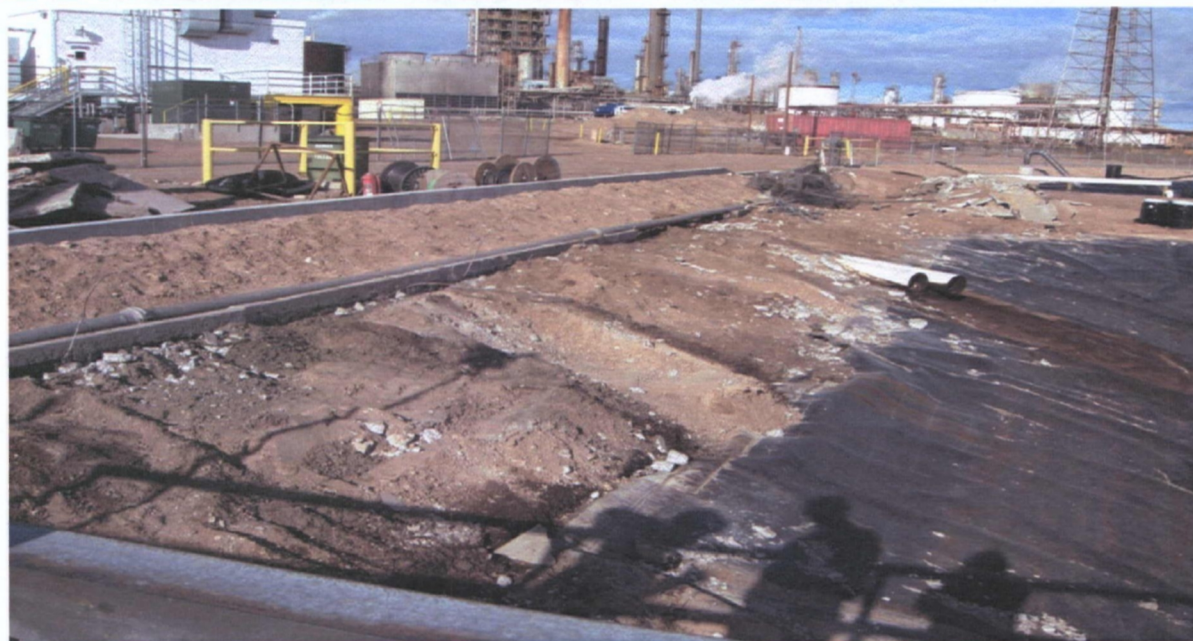
Photo: 10
Facility: Frontier Refining
Subject: Status of Pond 2
Photographer: Linda Jacobson
Date: October 17, 2011

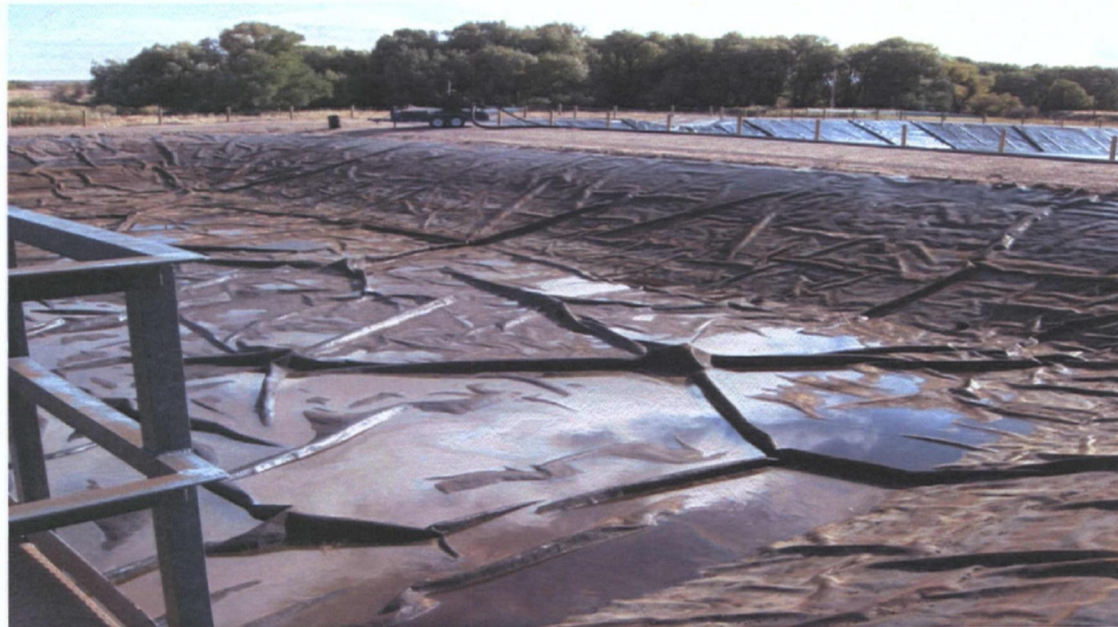
Photo: 11
Facility: Frontier Refining
Subject: Pond 2 Liner to Be Removed
Photographer: Linda Jacobson
Date: October 17, 2011

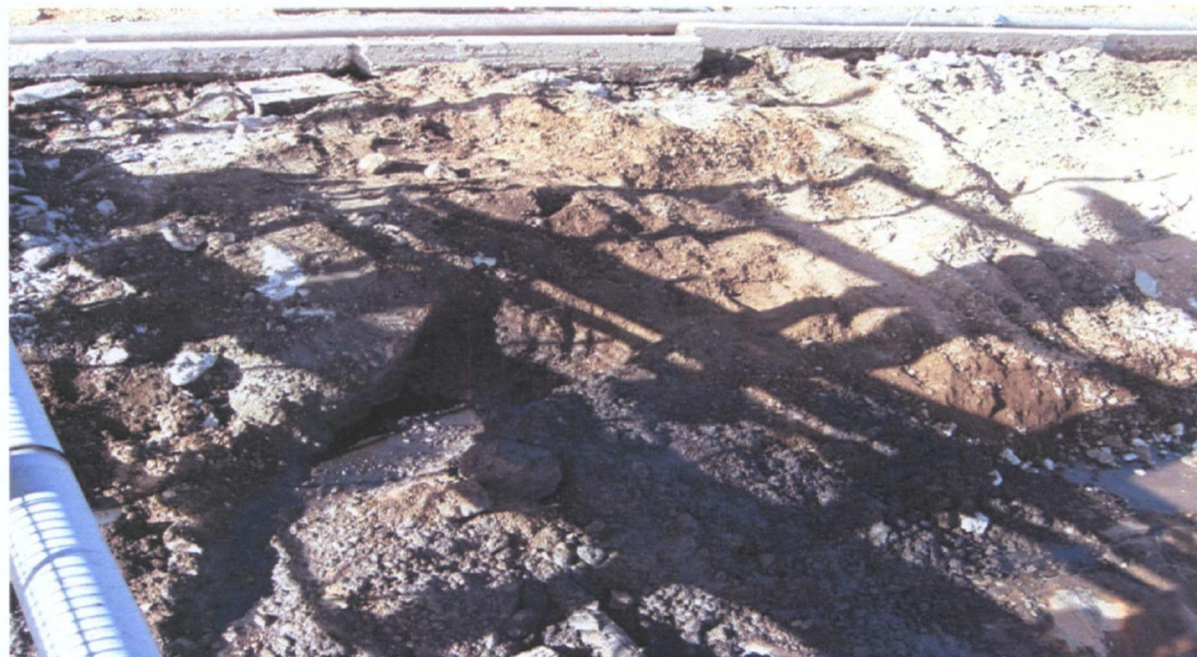
Photo: 12
Facility: Frontier Refining
Subject: Water Seep, Clear Constant
Stream of Water Uncovered
Photographer: Linda Jacobson
Date: October 17, 2011
